STREAM CHANNEL ADJUSTMENTS
FOLLOWING LOGGING ROAD REMOVAL
IN REDWOOD NATIONAL PARK

REDWOOD NATIONAL PARK
WATERSHED REHABILITATION

TECHNICAL REPORT
DECEMBER 1987

Redwood National Park Watershed Rehabilitation
Technical Report Number 23

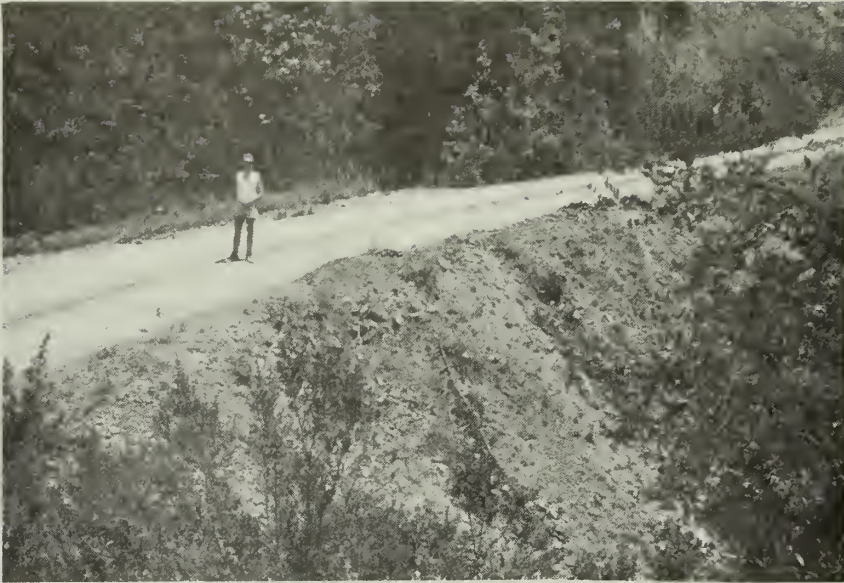
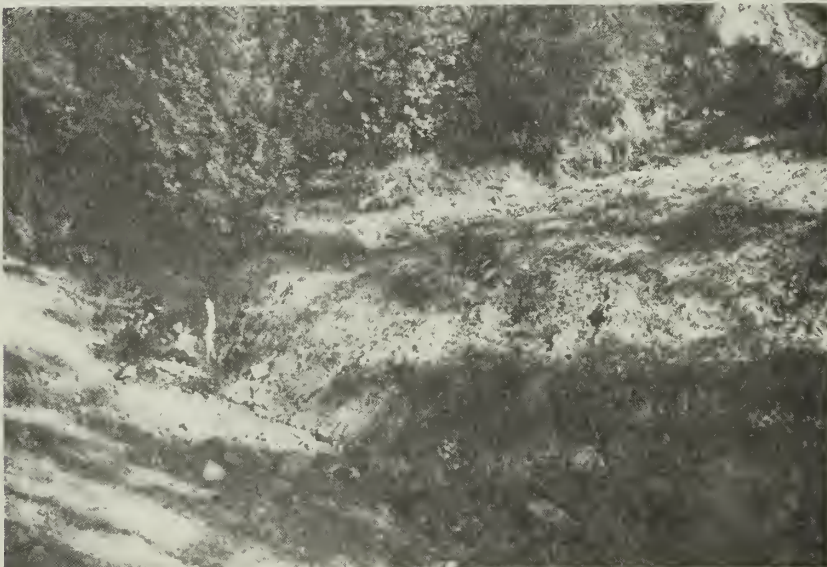
Figure 2. Logging road stream crossing before (A) and after (B) excavation. Excavation has uncovered cobbles and boulders that composed the original stream bed.

When roads are constructed across streams, a large amount of fill material (soil) is bulldozed into the stream channel to build the road bed up to grade. A major part of the ongoing watershed restoration program includes the removal of this road fill material from skid trail and haul road stream crossings (Figure 2). Excavation of road fill from stream crossings is given high priority because of the relatively high potential for significant erosional damage. For example, during extreme runoff events, plugged culverts may divert streamflow and cause gullyng of hillslopes and road beds while saturated stream crossings can fail as destructive debris torrents.

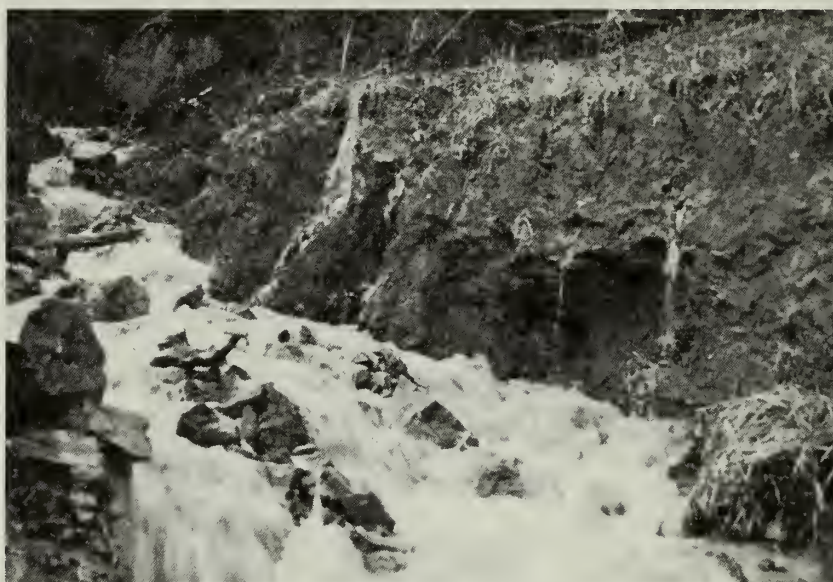
Figure 10. Left bank in Reach 6 following the storm of December 15, 1982. At the time this photo was taken (December 17, 1982), bank slumping continued to supply fine sediment to the channel, precluding or masking the development of a channel bed armor layer.

the field between Reach 6 and the other 23 reaches was the extremely saturated condition and resultant instability of streambanks along the upper portion of the reach (see Figure 10). It was noted during frequent visits to the study reaches that the streambanks adjacent to Reach 6 continued to slough and supply fine sediment to the channel well after stormflows had receded. In other reaches, banks appeared less mobile, allowing more opportunity for lag development by winnowing away of fines while storm discharges receded. From these observations, it was concluded that Reach 6 could be considered anomalous with respect to channel armoring due to the persistence of bank sloughing.

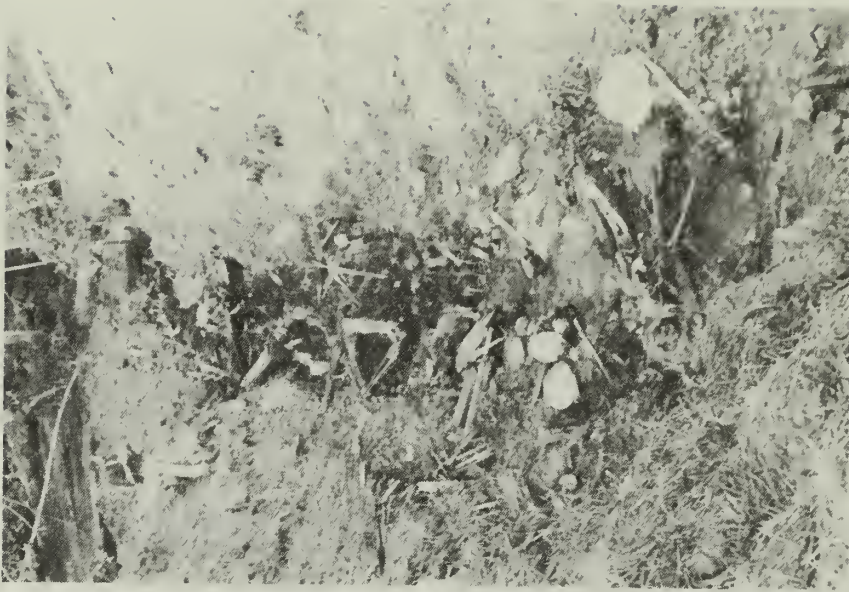
Figure 12. Before (A) and after (B) season photos of Reach 23 showing development of numerous steps composed of organic debris accumulations. Percent stream drop composed of organic steps (%ORGDROP) in this reach was relatively high at 45.5%.

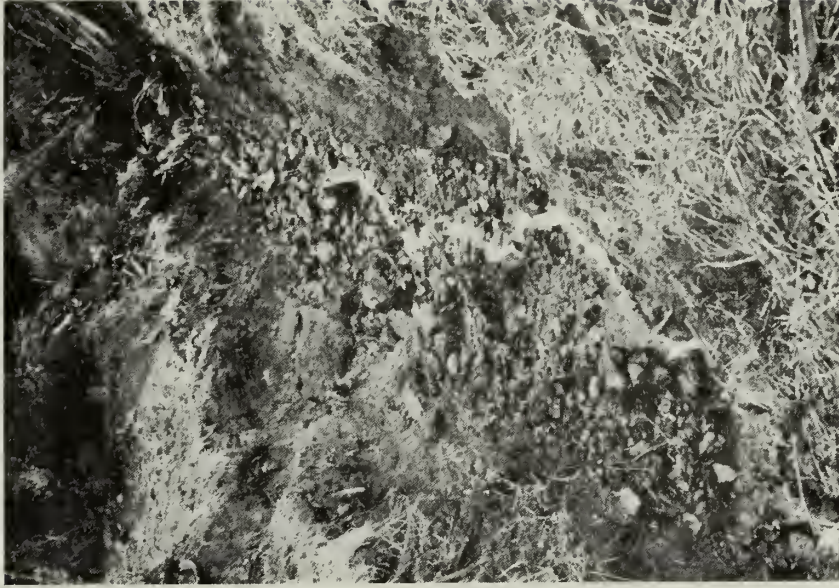
Figure 13. Before (A) and after (B) season photos of Reach 5 showing extensive scour and channel bed armor development. Percent stream elevation drop composed of organic steps (%ORGDROP) was relatively low (6.9%), as was the percent streambank material composed of boulders and cobbles (%B+C), accounting for the severe erosion occurring in this reach.
